## Fences and Walls

St. Joseph Landmark Commission

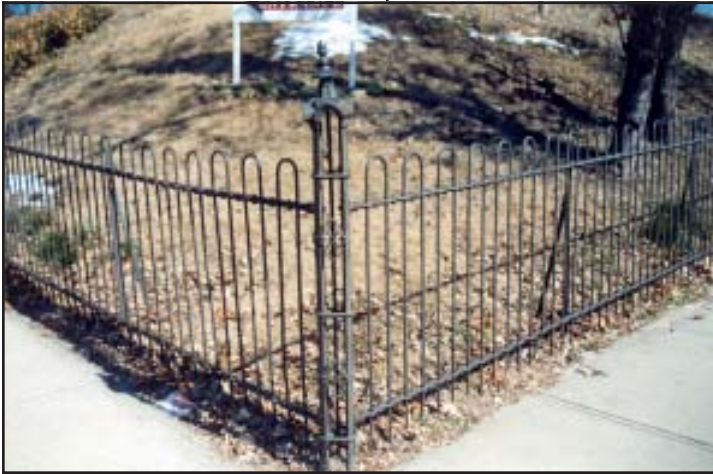
This cast iron fence in a hairpin design is located around the grounds of the former Wyeth-Tootle mansion, now the St. Joseph Museum, 1100 Charles Street, Museum Hill Historic District.

Many residential properties in St. Joseph were once surrounded by ornamental iron fences. Historically, there were two major types of metal fencing – wrought iron and cast iron. Wrought iron is made from iron bars that are fired under extreme heat until they reach a pliable state and are then pounded, cut, and formed into the desired shape through a process called hand-forging. Thus, each piece of wrought iron is truly custom made and unique. Cast iron, by contrast, is made from molten metal poured into molds. A multitude of designs crafted from wooden molds created a remarkable diversity of patterns, many of which were mass-produced in foundries. Cast iron represents the most common historic fencing material remaining in St. Joseph today. One of the most common fence patterns is the hairpin and spike which is found in numerous locations in the City's older, established neighborhoods.

Due to the brittle nature of cast iron, fences that remain today often have missing finials, spikes, posts, and gates. Luckily, these fence components are still manufactured, albeit in steel or cast aluminum. Suitable replacements, particularly for the more common fence designs, can be purchased either through architectural salvage companies or manufacturers such as Stewart Iron Works Company of Covington, Kentucky, which has produced the same fence designs since 1886.

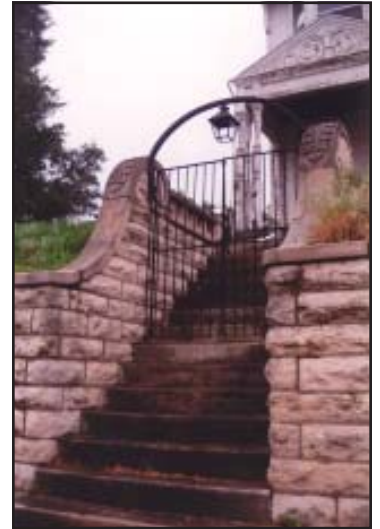
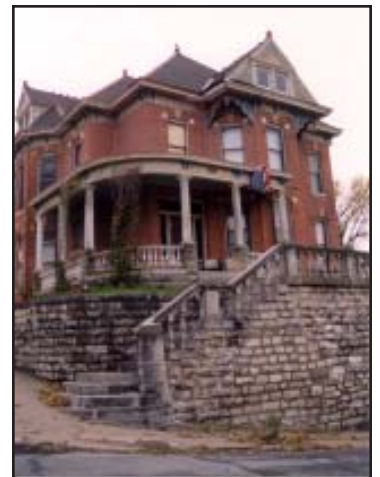
Many of St. Joseph's Victorian residences incorporated elaborate stone carvings and staircase railings into ashlar stone retaining walls to define their entrances.

In addition to traditional fencing, masonry retaining walls are characteristic of St. Joseph's hilly topography. Many of these walls were constructed of limestone in varying patterns and were either dry-laid or more commonly set with mortar. The simplest stone wall type is the random rubble masonry wall consisting of irregular, randomly-dimensioned natural stones that are laid without continuous horizontal joints. This produces a rustic and informal wall design. Coursed rubble walls are made from irregular stone that is laid in recognizable rows or courses. Many of the walls found in the City's historic districts have regularly shaped, block-like stones known as ashlar. Random ashlar walls are made of blocks of ashlar stone of varying sizes that permit close-fitting joints. Regularly shaped stone blocks of the same size that produce continuous horizontal joints in precise patterns are used to create coursed ashlar walls. Frequently mortar joints between stones were tooled or formed to create visual interest and added texture to the wall. Large rectangular caps of stone were often added to protect the masonry from water infiltration and to provide a visual termination to the wall. Stone or brick walls were frequently parged or stuccoed and scored to resemble large blocks of stone. On walls surrounding some of St. Joseph's finest residential properties, elaborate walls were sometimes constructed with large newel posts and stairway cheek walls with carved sandstone ornament in foliated designs or with recessed or raised panels. Wall sections often incorporated entry stairs made of blocks of stone or poured concrete. Stone railings with turned balusters or iron railings provided further architectural interest to these building site features.

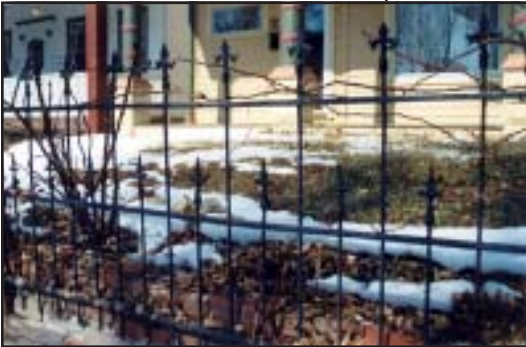
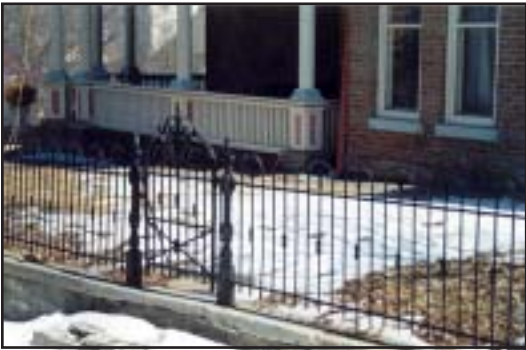
Wrought iron fences found in the City's historic districts show a remarkable diversity of design.

Straightening bent metal sections of wrought iron fencing can usually be accomplished by a competent blacksmith or metal works shop that specializes in hand-forged work. The metal is reformed by subjecting it to intense heat and pounding or bending it back into shape. Cast iron, on the other hand, is a very brittle iron that tends to break rather than bend. Repairs will usually involve the production of new pieces formed from molds matching the original pieces.

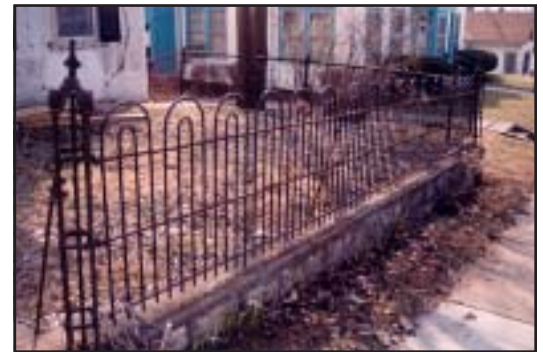
More examples of cast iron fencing found in St. Joseph's historic districts.

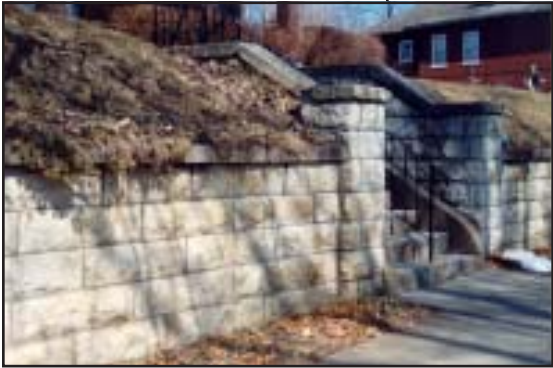
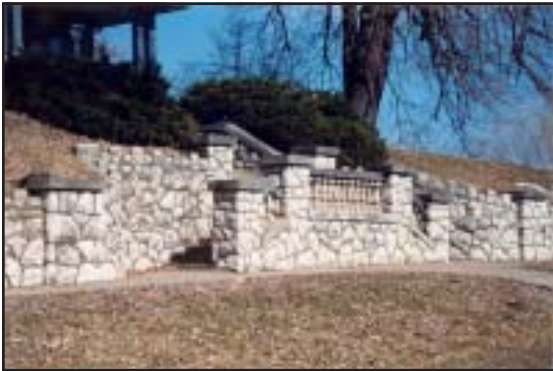
Coursed ashlar retaining walls (top) consist of regularly shaped stone blocks of the same size that provide continuous horizontal joints. Random rubble retaining walls (bottom) consist of irregular, randomly dimensioned natural stones laid without continuous mortar joints.

Retaining walls often fail as a result of the effects of the freeze-thaw cycle. Moist soil that freezes in winter will expand and cause a masonry wall to move resulting in the failure of mortar joints. Likewise, movement will also occur in spring when the soil contracts. Water penetration into masonry, erosion of soil behind the wall, and root systems from plantings can also contribute to its failure. New masonry retaining walls should be set on deep footings that are set well below the frost line. Mortar joints should be maintained and efforts should be made to minimize water penetration to the top of the wall through the installation of a cap. Joints in the capstones should be sealed. Deteriorated stones should be replaced as evidence of spalling occurs. Walls should be monitored for evidence of leaning and bulging and corrective measures taken before collapse occurs.

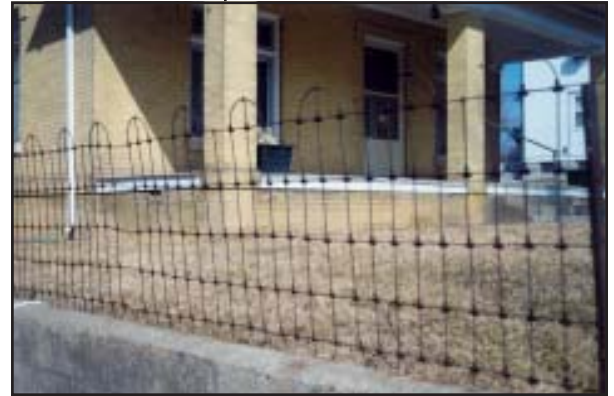
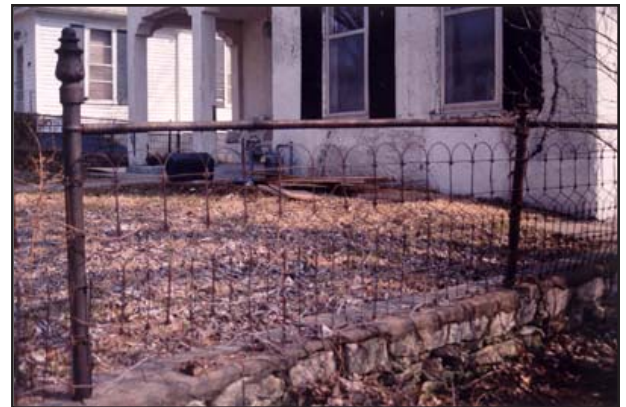
Woven wire fencing, the forerunner of modern chain link fencing, is still found in some of the city's historic districts. The top example is located on the 1100 block of Ridenbaugh Street in the Cathedral Hill Historic District. The bottom photo shows a fence located on the 1800 block of Clay Street, Kemper Additoin Historic District.

Woven wire fences, the forerunner of modern chain link fencing, first became available by the mid-19<sup>th</sup> century in this country. The earliest wire fences were formed from molten iron that was drawn from dies to produce wires 1/8" to 1/2" in diameter. Lengths of wire were then cold-bent around jigs to form diamond and loop patterns or were crimped for decorative effect. By the early 20<sup>th</sup> century, technological advances in wire production begun in Germany allowed for development of thinner, braided or woven welded wire that could easily be formed into a variety of patterns. Today, remnants of this early 20<sup>th</sup> century wire fencing are found in the City's older, historic neighborhoods
