Roofs

St. Joseph Landmark Commission

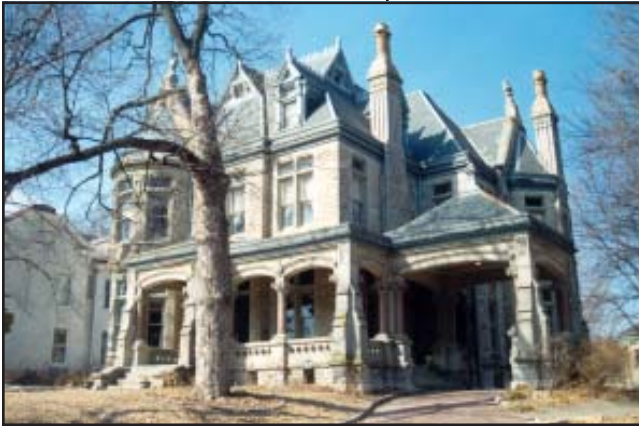
A significant character-defining feature of the Nathan Ogden house, 809 Hall Street, Hall Street Historic District, is its multiple hipped roof complete with slate sheathing, copper ridging, cresting, dormers, stone finials, and towering corbelled chimneys.

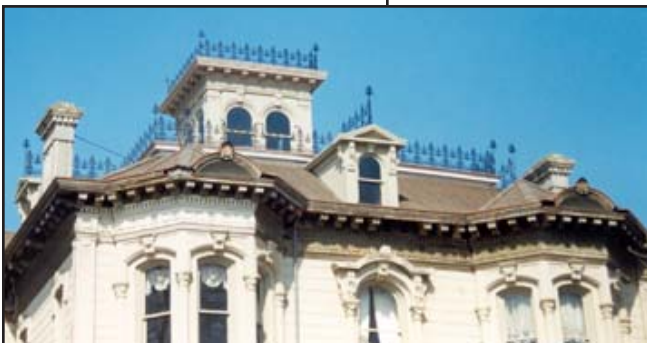
Ornamental iron cresting embellishes the main roof, cupola and dormers of the Adam Schuster Mansion, 703 Hall Street, Museum Hill Historic District.

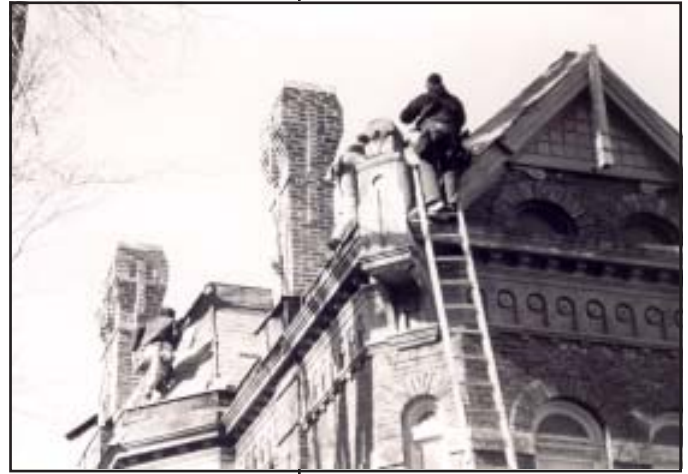
Workers install new slate shingles on the roof of the John Shireman, Jr. house, 120 S. 15th Street, Museum Hill Historic District.

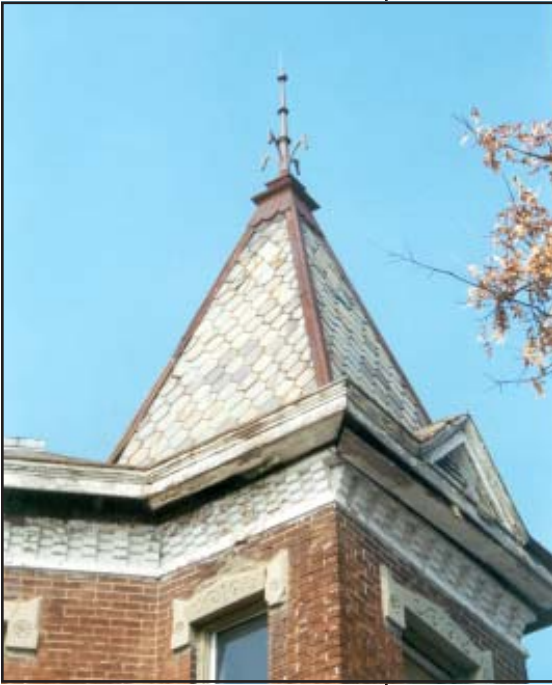
Built-in guttering failure often leads to soffit and eave damage if not corrected. Despite the deterioration, note the intact hexagonal slate tiles, metal ridging, and finial on the tower of the Louis Stigers house, 1023 Church Street, Cathedral Hill Historic District.

Guttering systems play an equally important role in protecting a building from water damage. The most common forms of guttering found on older residential buildings in St. Joseph are built-in, yankee, and half-round (eaves trough) types. Each of these guttering systems has its own unique set of maintenance and repair problems. Built-in gutters are typically integrated into a boxed cornice which can then be ornamented with moldings, bracketing, and panels to create a distinctive ornamental feature at the eave line. Many of these cornices are fashioned of sheet metal. Others are made of wood. The major advantage of the built-in gutter is that it is completely invisible from the ground. When repairing or replacing built-in gutters, the new sheet metal material used to line the gutter should be corrosion resistant and all joints and patches must be soldered. This precludes the use of aluminum which can not be soldered. Galvanized steel and copper are the best choices. Care should also be taken to ensure that the wooden boxed frame that supports the gutter is in sound condition. Sagging or deflected structural members can adversely effect the slope and draining capacity of the gutter.
