# Wood Siding, Trim & Ornamentation

St. Joseph Landmark Commission

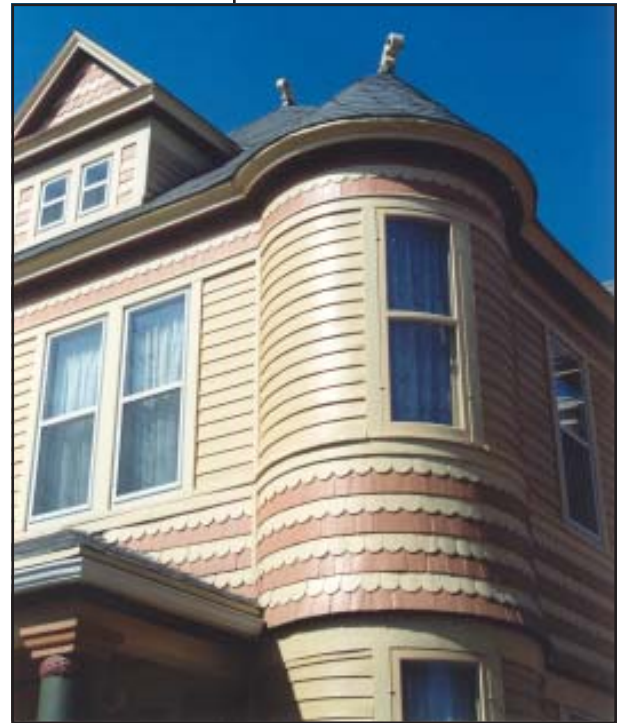
Wood clapboard siding, decorative shingle beltcourses, and dormer gable ornamentation embellish the exterior of the George Schneider house, 1921 Francis Street, Harris Addition Historic District.

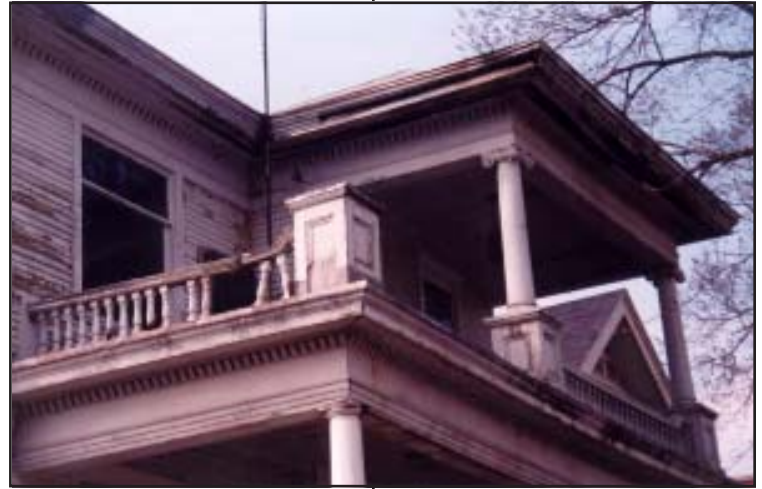
Conditions such as peeling paint and wood rot are often the result of improper paint preparation, roof leaks, or non-functioning gutters on building exteriors.

Problems such as peeling paint and rot are primarily the result of improper paint preparation techniques. Improperly functioning guttering and flashing systems and the lack of adequate sloping of building elements to shed water can also contribute to the problem. Cracks and joints in wood, particularly where siding and trim pieces abut, should be inspected regularly and caulked as necessary with a high quality sealant. (Horizontal lap joints should not be caulked.) Avoid the use of silicone sealants that are not paintable.

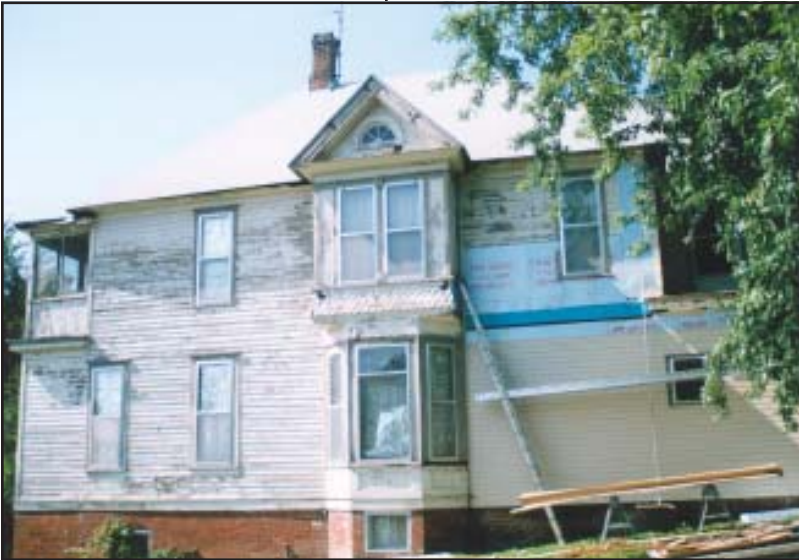
When wooden elements are too deteriorated to repair, remove only those elements that are beyond repair. Splice in new pieces of wood, if possible. Reinforce damaged wooden elements with new wooden elements as another means of retaining original fabric. The availability of wood epoxies in the marketplace today has also made it possible to recondition and rebuild rotted wooden trim and ornamentation. Epoxies, polymers, and synthetic resins can be used to fill cavities and build up partially rotted areas. Impregnation of damaged wood fibers with certain epoxy products will help to ensure the retention of original fabric and will often leave the wood stronger than it was originally.

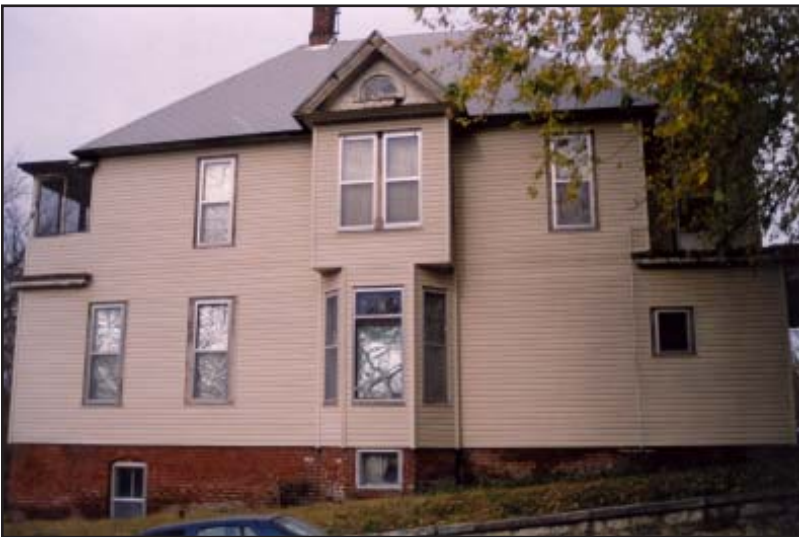
Vinyl siding is installed on this N. 9<sup>th</sup> Street Queen Anne house resulting in the obscuring of decorative shingles and wood panels in the bay window area.

Poor installation of synthetic sidings is also problematic. Applications frequently result in the damaging, obscuring, or removal of architectural features. Profiles of door and window trim are invariably changed and distinctive building features that can not be replicated with the new product are lost in the installation. Thus, the character of the historic resource is diminished.

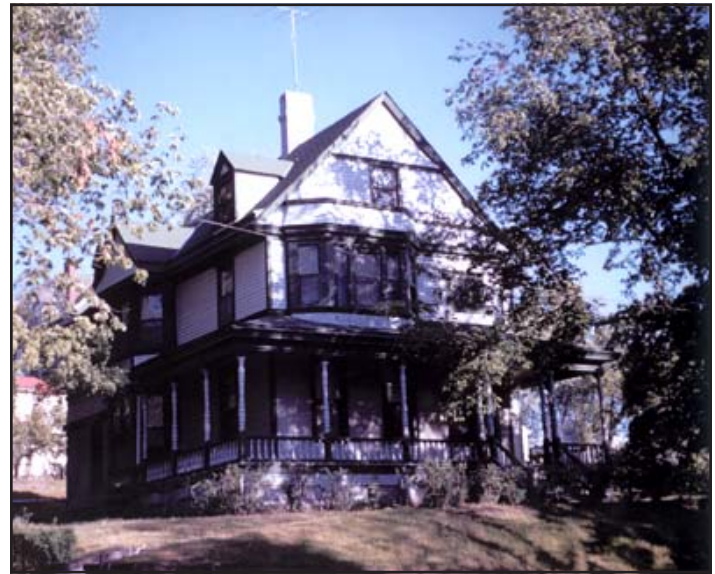
Before

A 1960’s “update” of the Queen Anne style Henry White House, 503 S. 11th Street, Museum Hill Historic District resulted in the loss of the house’s generous wraparound porch, decorative shingle bands and narrow profile wood siding. Current owners plan to restore the house back to its original c. 1888 appearance.
